Town of Arlington, Massachusetts

PART A – Executive Summary Self- Evaluation and Transition Plan

November 2019

Part A – Executive Summary

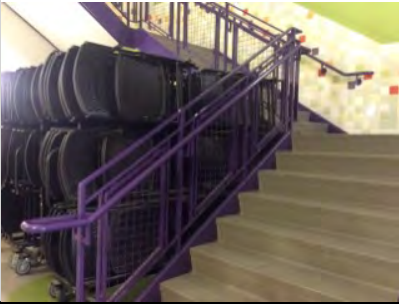
ID	Location	Floor	Room	Element	Type	Photo	Issues	Current Measure	Recommendations	Quantity	Price	Cost Estimation
Best Practice												
9	Stair 1	1			Stairs

Best Practice		Best Practice: Consider adding color-contrasting strips at each stair tread to improve access for people who are blind or low-vision.	1	--	\$0
Toilet Rooms for Children												
10	Toilet Room Near 112	1		Single-User Toilet	N/A

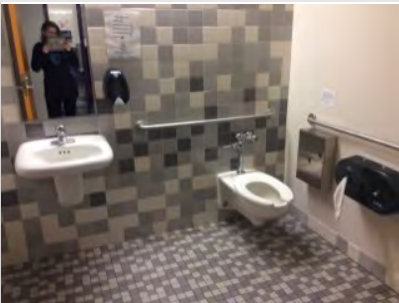
Non-compliant toilet paper dispenser	-	Replace the toilet paper dispenser as it does not allow continuous paper flow.	1	353	\$353
Approach and Entrance												
11	Exit 6	1	101	Emergency Exit	N/A

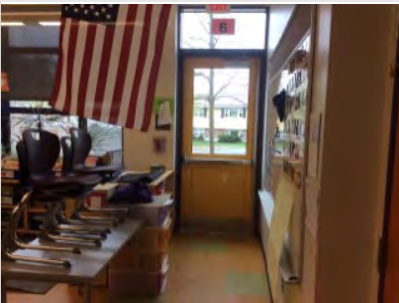
International Symbol of Acc. not provided	- -	Provide the International Symbol of Accessibility on the illuminated exit sign above the exit door.	1	116	\$116
Approach and Entrance												
12	Exit 10 (Labeled 8 on Plan)	1	102	Emergency Exit	N/A

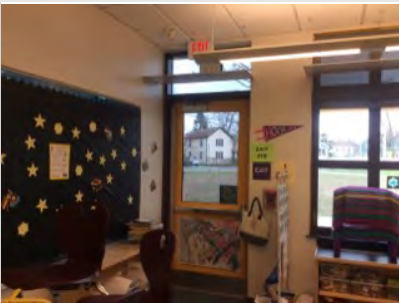
International Symbol of Acc. not provided	-	Provide the International Symbol of Accessibility on the illuminated exit sign above the exit door.	1	116	\$116

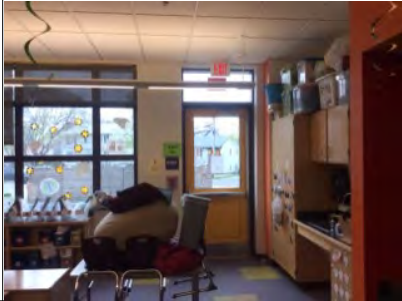
ID	Location	Floor	Room	Element	Type	Photo	Issues	Current Measure	Recommendations	Quantity	Price	Cost Estimation
Approach and Entrance												
13	Exit 4	1	103	Emergency Exit	N/A

International Symbol of Acc. not provided	-	Provide the International Symbol of Accessibility on the illuminated exit sign above the exit door.	1	116	\$116
Access to Goods and Services												
14	Kindergarten Classroom	1	104	Signage	Designation

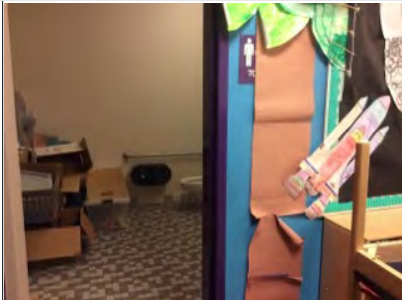
Not provided	-	Remove paper that is obstructing the tactile sign.	1	Labor	\$0
Toilet Rooms for Children												
15	Kindergarten Toilet Room	1	104	Single-User Toilet	N/A

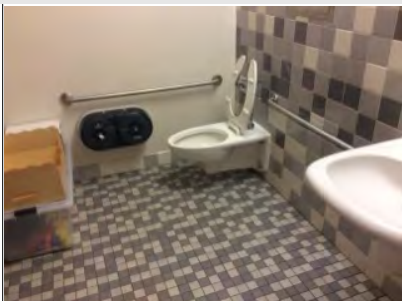
Non-compliant toilet paper dispenser	-	Replace the toilet paper dispenser as it does not allow continuous paper flow.	1	353	\$353
16	Kindergarten Toilet Room	1	104	Single-User Toilet	N/A

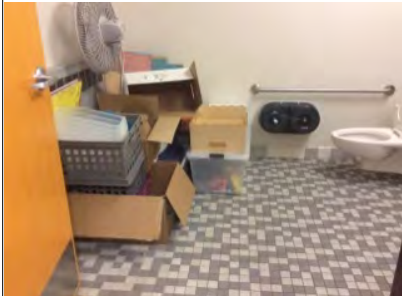
Clearance at toilet < 72" clear depth (MAAB)	-	Relocate boxes to ensure that there is 72" deep min. at the toilet.	1	Labor	\$0

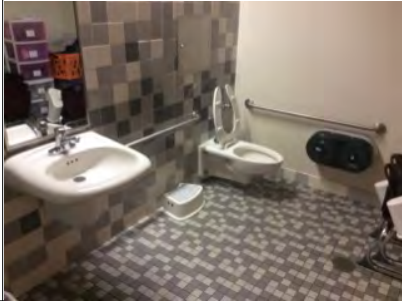
ID	Location	Floor	Room	Element	Type	Photo	Issues	Current Measure	Recommendations	Quantity	Price	Cost Estimation
Toilet Rooms for Children												
17	Kindergarten Toilet Room	1	105	Single-User Toilet	N/A

Non-compliant toilet paper dispenser	-	Replace the toilet paper dispenser as it does not allow continuous paper flow.	1	353	\$353
18	Kindergarten Toilet Room	1	105	Single-User Toilet	N/A

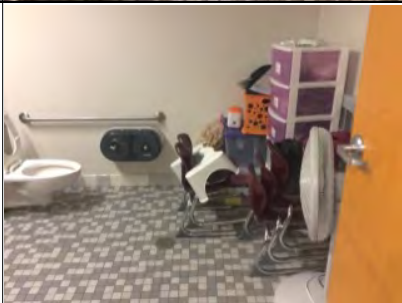
Clearance at toilet < 72" clear depth (MAAB)	-	Relocate boxes and stored items to ensure that there is 72" deep min. at the toilet.	1	Labor	\$0
Access to Goods and Services												
19	First Grade Classroom	1	107	Doors, Doorways, & Gates	Classroom

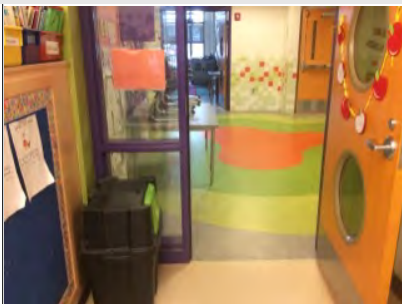
Maneuvering clearance(s) not provided	-	Remove the bin from the maneuvering clearance along the latch side of the door.	1	Labor	\$0
20	First Grade Classroom	1	107	Interior Access Route	N/A

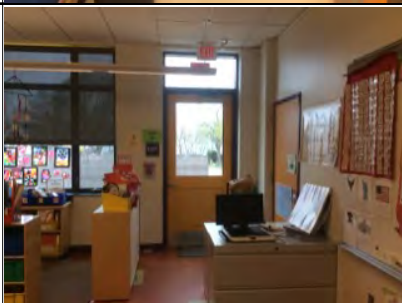
Route < 36" wide	30"	Reconfigure furniture to ensure that 36" min. is maintained at the accessible route.	1	Labor	\$0

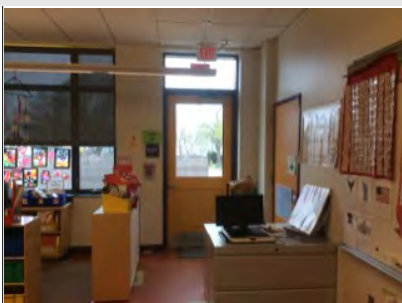
Approach and Entrance												
21	First Grade Classroom Exit	1	107	Emergency Exit	N/A

International Symbol of Acc. not provided	-	Provide the International Symbol of Accessibility on the illuminated exit sign above the exit door.	1	116	\$116

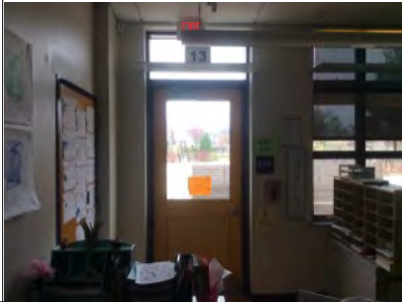
ID	Location	Floor	Room	Element	Type	Photo	Issues	Current Measure	Recommendations	Quantity	Price	Cost Estimation
Approach and Entrance												
22	Exit 13 (Labeled 11 on Plan)	1	108	Emergency Exit	N/A

International Symbol of Acc. not provided	-	Provide the International Symbol of Accessibility on the illuminated exit sign above the exit door.	1	116	\$116
Approach and Entrance												
23	Exit 2	1	109	Emergency Exit	N/A

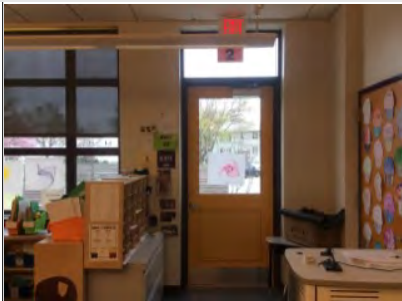
International Symbol of Acc. not provided	-	Provide the International Symbol of Accessibility on the illuminated exit sign above the exit door.	1	116	\$116
Access to Goods and Services												
24	First Grade Classroom	1	109	Interior Access Route	N/A

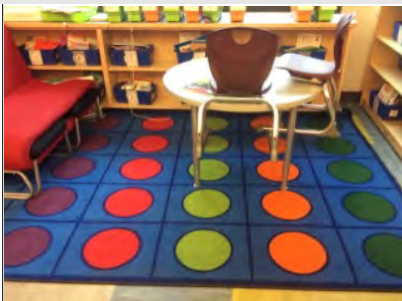
Surface not stable, firm, and slip-resistant	-	Secure the mat.	1	Labor	\$0
25	First Grade Classroom	1	109	Interior Access Route	N/A

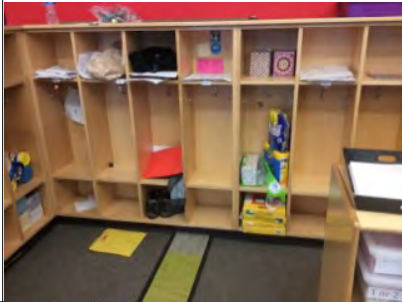
Surface not stable, firm, and slip-resistant	-	Secure the mats.	3	Labor	\$0

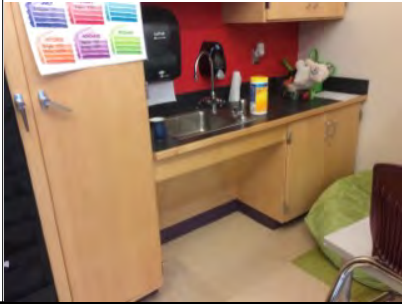
ID	Location	Floor	Room	Element	Type	Photo	Issues	Current Measure	Recommendations	Quantity	Price	Cost Estimation
Additional Access												
26	First Grade Classroom	1	109	Sink	Classroom

Toe and knee clearances not provided	17"	Ensure there is knee and toe clearance that is at least 19" deep.	1	843	\$843
Access to Goods and Services												
27	Health Suite	1	112	Doors, Doorways, & Gates	Circulation

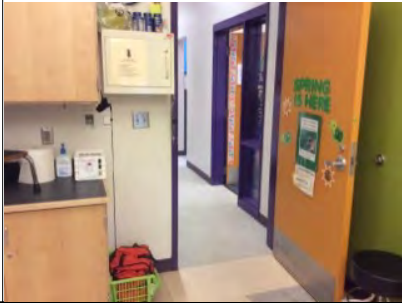
Maneuvering clearance(s) not provided	-	Relocate the white box and green storage bin from the maneuvering clearance along the latch side of the door.	1	128 Labor	\$128
Additional Access												
28	Health Suite	1	112	Sink	Classroom

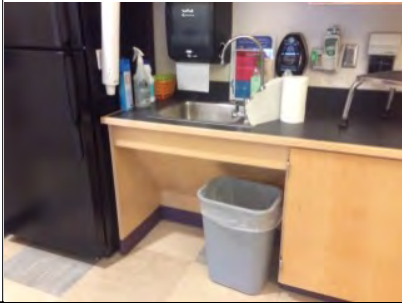
Toe and knee clearances not provided	-	Remove trash bin from under sink.	1	Labor	\$0
Toilet & Bathing Rooms												
29	Single-User Toilet Room in Health Suite	1	112	Single-User Toilet	N/A

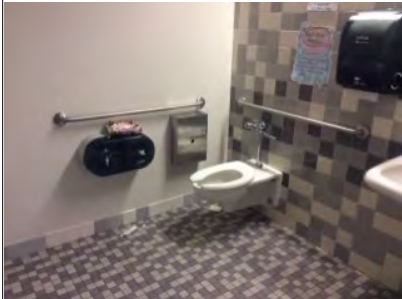
Toilet paper dispenser is not compliant	-	Replace toilet paper dispenser as it does not allow continuous paper flow.	1	353	\$353

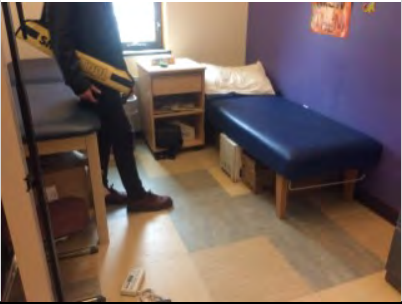
Best Practice		Best Practice: Consider providing an adjustable height exam table.	1	--	\$0
Approach and Entrance												
31	Exit 20 (Labeled 18 on Plan)	1	115	Emergency Exit	N/A

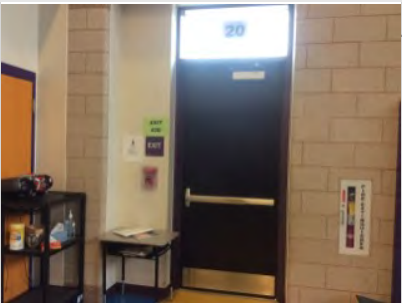
International Symbol of Acc. not provided	-	Provide the International Symbol of Accessibility on the illuminated exit sign above the exit door.	1	116	\$116
Access to Goods and Services												
32	Near Gym	1	115	Operable Parts	Equipment

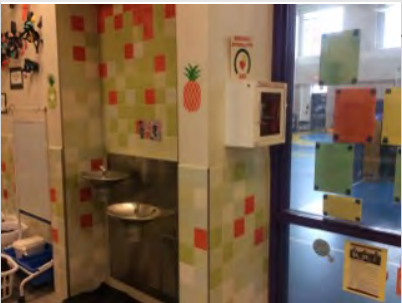
Reach < 15" or > 48"(forward/side approach)	55"	Relocate defibrillator so that controls are between 48" max. above the finished floor.	1	128	\$128
Approach and Entrance												
33	Exit 15 (Labeled Exit 13 on Plans)	1	116	Emergency Exit	N/A

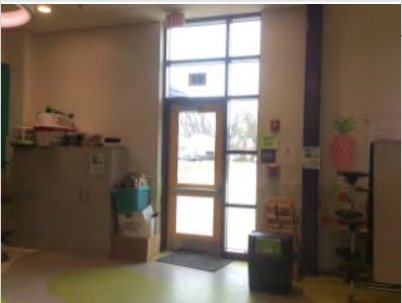
International Symbol of Acc. not provided Mat not securely attached	- -	Provide the International Symbol of Accessibility on the illuminated exit sign above the exit door. Secure the mat.	1	116 Labor	\$116

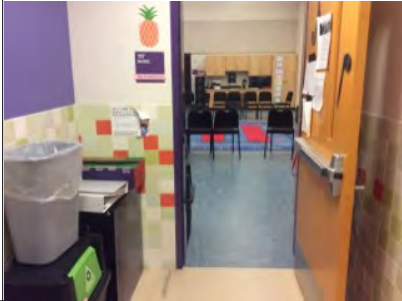
Maneuvering clearance(s) not provided	-	Remove the storage bin from the maneuvering clearance along the latch side of the door.	1	Labor	\$0
35	Music Room	1	117	Interior Access Route	N/A

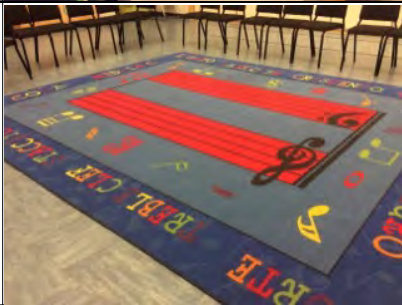
Surface not stable, firm, and slip-resistant	-	Secure the mat.	1	Labor	\$0
36	Music Room	1	117	Ramps	Interior

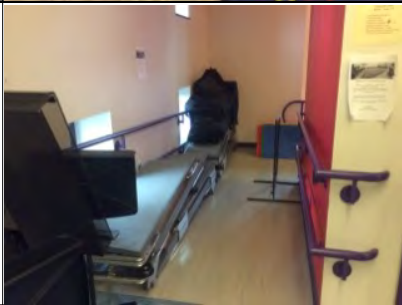
Ramp < 48" wide	-	Relocate items that are stored on the ramp.	1	Labor	\$0
Access to Goods and Services												
37	Route to the Music Room	1	117	Ramps	Interior

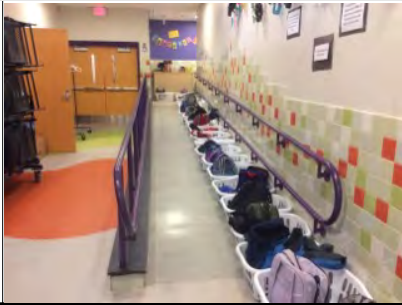
Ramp < 48" wide	-	Remove storage bins from the ramp.	1	Labor	\$0
Approach and Entrance												
38	Exit 17 (Labeled Exit 15 on Plans)	1	124	Emergency Exit	N/A

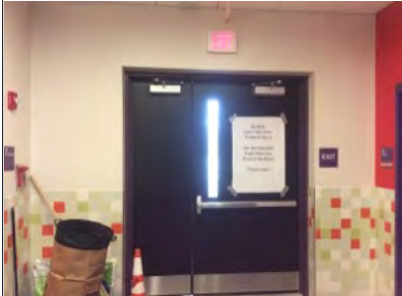
International Symbol of Acc. not provided	- -	Provide the International Symbol of Accessibility on the illuminated exit sign above the exit doors.	1	116	\$116

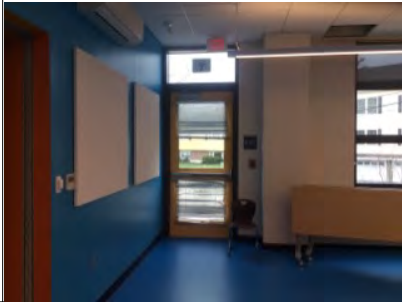
International Symbol of Acc. not provided	-	Provide the International Symbol of Accessibility on the illuminated exit sign above the exit door.	1	116	\$116
Approach and Entrance												
40	Exit 9	1	A102	Emergency Exit	N/A

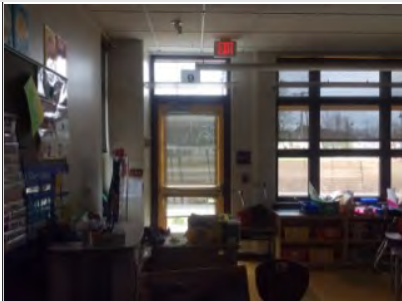
International Symbol of Acc. not provided	-	Provide the International Symbol of Accessibility on the illuminated exit sign above the exit door.	1	116	\$116
Access to Goods and Services												
41	Kindergarten	1	A102	Doors, Doorways, & Gates	Classroom

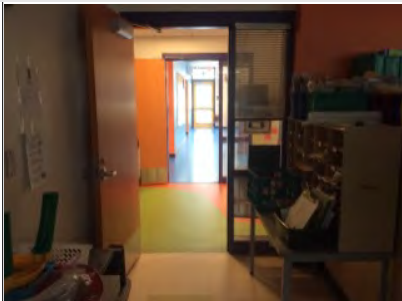
Maneuvering clearance(s) not provided	-	Remove the table from the maneuvering clearance along the latch side of the door.	1	Labor	\$0
Toilet Rooms for Children												
42	Boys' Toilet Room	1	T11	Toilet Compartment	Accessible Compartment

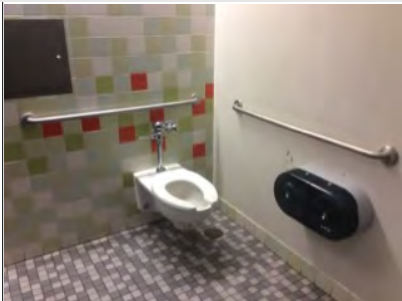
Door with malfunctioning self-closing hinge Toilet seat < 12" or > 15" high (Ages 5 - 8) Side or rear grab bar < 20" or > 25" high (Ages 5 - 8) Centerline < 12" or > 15" (Ages 5 - 8) Non-compliant toilet paper dispenser	- 18" 34" 19" -	Repair self-closing hinge. Install a toilet with a seat between 12"- 15" high above the finished floor. Relocate grab bar to 20"- 25" above the floor. Relocate toilet so that the centerline is between 12" and 15" from the side wall. Replace the toilet paper dispenser as it does not allow continuous paper flow.	1	1895	\$1895

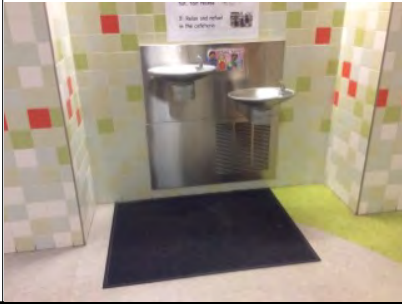
Mat not securely attached	-	Secure the mat.	1	Labor	\$0
Toilet Rooms for Children												
44	Girls' Toilet Room	1	T12	Toilet Compartment	Accessible Compartment

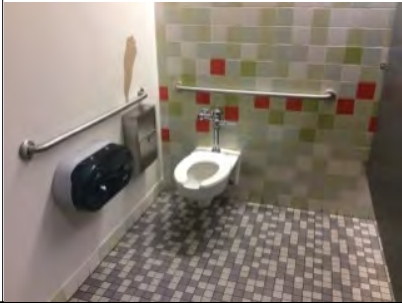
Door with malfunctioning self-closing hinge Toilet seat < 12" or > 15" high (Ages 5 - 8) Side or rear grab bar < 20" or > 25" high (Ages 5 - 8) Centerline < 12" or > 15" (Ages 5 - 8) Non-compliant toilet paper dispenser	- 18.5" 34" 18" -	Repair self-closing hinge. Install a toilet with a seat between 12"- 15" high above the finished floor. Relocate grab bar to 20"- 25" above the floor. Relocate toilet so that the centerline is between 12" and 15" from the side wall. Replace the toilet paper dispenser as it does not allow continuous paper flow.	1	1895	\$1895

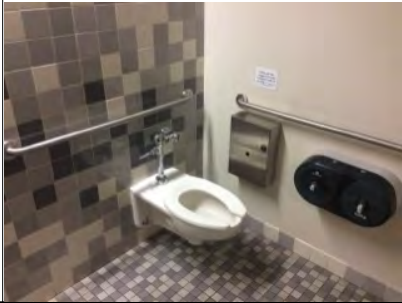
Toilet paper dispenser is not compliant	-	Replace toilet paper dispenser as it does not allow continuous paper flow.	1	353	\$353
Toilet Rooms for Children												
46	Boys' Toilet Room	2		Toilet Compartment	Accessible Compartment

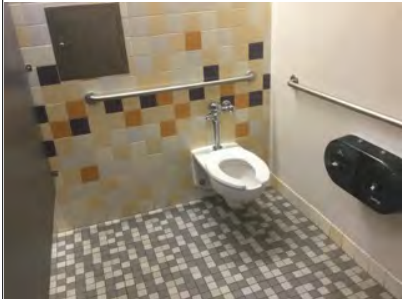
Toilet seat < 15" or > 17" high (Ages 9 - 12) Side or rear grab bar < 25" or > 27" high (Ages 9 - 12) Centerline < 15" or > 18" (Ages 9 - 12) Non-compliant toilet paper dispenser	18" 34" 19" -	Toilet seat height and toilet centerline are not compliant but usable. Relocate grab bars to 25"- 27" above the floor. Replace the toilet paper dispenser as it does not allow continuous paper flow.	1	1059	\$1059

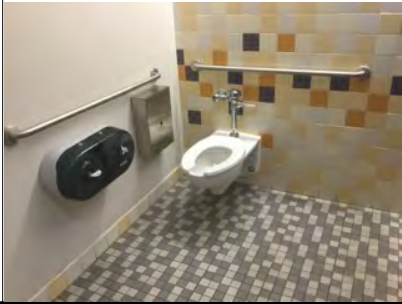
Toilet seat < 15" or > 17" high (Ages 9 - 12) Side or rear grab bar < 25" or > 27" high (Ages 9 - 12) Centerline < 15" or > 18" (Ages 9 - 12) Non-compliant toilet paper dispenser	18" 34" 19" -	Toilet seat height and toilet centerline are not compliant but usable. Relocate grab bars to 25"- 27" above the floor. Replace the toilet paper dispenser as it does not allow continuous paper flow.	1	1059	\$1059
Access to Goods and Services												
48	Third Grade Classroom	2	201	Interior Access Route	N/A

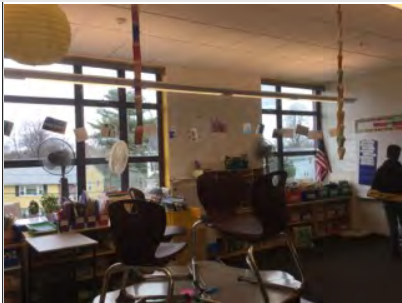
Obstructed by protruding objects	-	Remove paper chains, or ensure they are 80" from the finished floor min.	1	Labor	\$0
Access to Goods and Services												
49	Third Grade Classroom	2	202	Interior Access Route	N/A

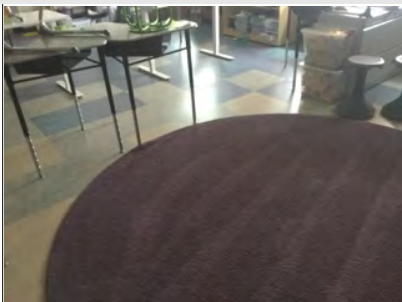
Surface not stable, firm, and slip-resistant	-	Secure the mat.	1	Labor	\$0

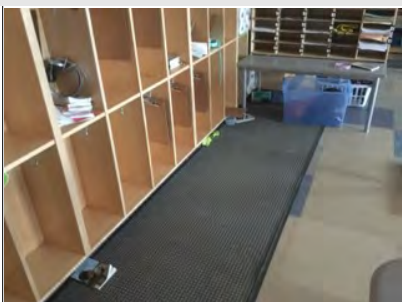
Access to Goods and Services												
50	Third Grade Classrooms	2	202 203	Interior Access Route	N/A

Surface not stable, firm, and slip-resistant	-	Secure the mats.	2	Labor	\$0

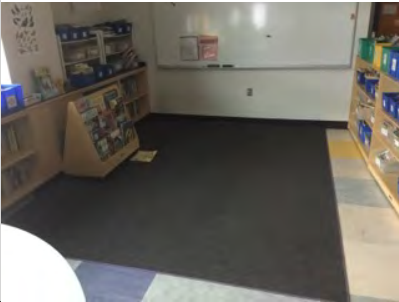
Surface not stable, firm, and slip-resistant	-	Secure the mat.	1	Labor	\$0
52	Third Grade Classroom	2	203	Interior Access Route	N/A

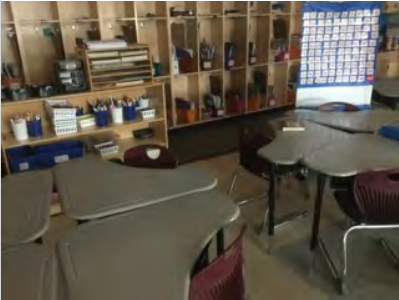
Route < 36" wide	-	Reconfigure furniture to ensure that 36" min. is maintained at the accessible route.	1	Labor	\$0
Access to Goods and Services												
53	Third Grade Classrooms	2	203 202	Dining or Work Surfaces	Work Surface

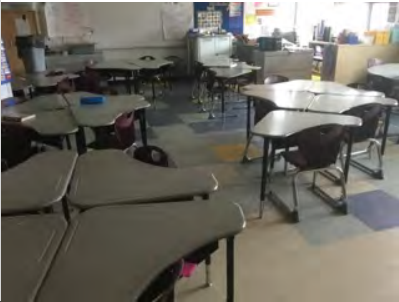
At least one or 5% accessible tables not provided	27" wide	Provide at least one (1) accessible desk with 24" min. knee clearance and 30" min. clear width.	2	350	\$700
Access to Goods and Services												
54	Second Grade Classroom	2	207	Dining or Work Surfaces	Work Surface

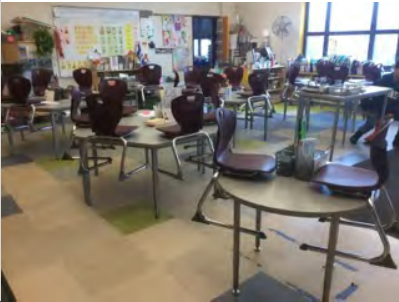
At least one or 5% accessible tables not provided	-	Provide at least one (1) accessible desk with 24" min. knee clearance and 30" min. clear width.	1	350	\$350

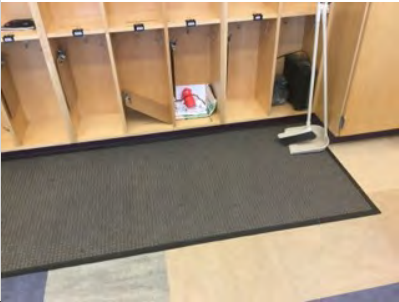
Surface not stable, firm, and slip-resistant	-	Secure the mats.	2	Labor	\$0
Access to Goods and Services												
56	Second Grade Classroom	2	210	Interior Access Route	N/A

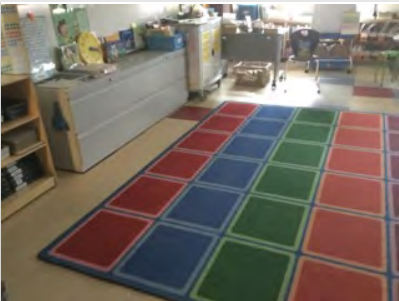
Surface not stable, firm, and slip-resistant	-	Secure the mat.	1	Labor	\$0
57	Second Grade Classroom	2	210	Interior Access Route	N/A

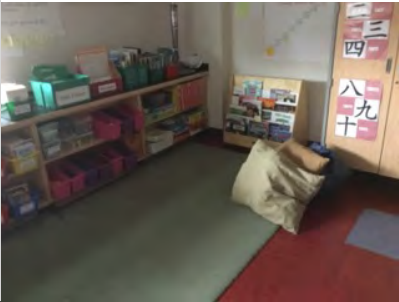
Surface not stable, firm, and slip-resistant	-	Secure the mat.	1	Labor	\$0
Additional Access												
58	Second Grade Classroom	2	210	Sinks for Children's Use	Classroom

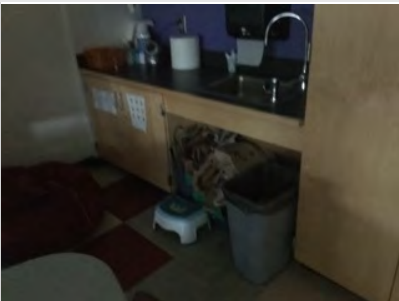
Knee or toe clearance not provided		Remove trash bin from under the sink.	1	Labor	\$0

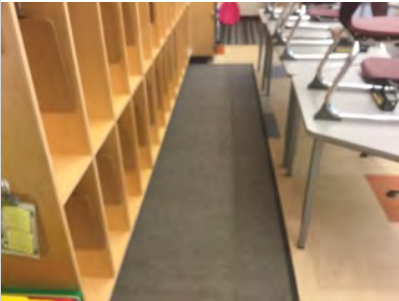
Surface not stable, firm, and slip-resistant	-	Secure the mat.	1	Labor	\$0
60	Second Grade Classroom	2	211	Interior Access Route	N/A

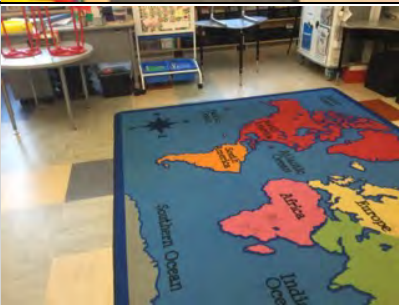
Surface not stable, firm, and slip-resistant	-	Secure the mat.	1	Labor	\$0
61	Second Grade Classroom	2	211	Operable Parts	Equipment

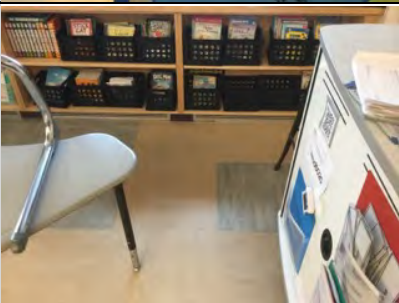
Clear floor space is not provided	-	Provide a 30" min. by 48" min. clear floor space at the iPad cabinet and books.	1	Labor	\$0
62	Second Grade Classroom	2	211	Interior Access Route	N/A

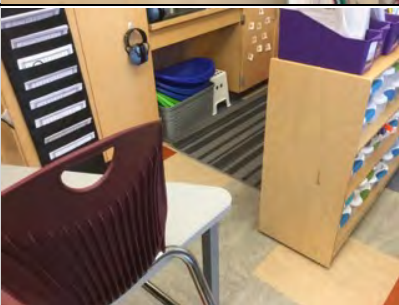
Route < 36" wide	20"	Reconfigure furniture to ensure that 36" min. is maintained at the accessible route.	1	Labor	\$0
Access to Goods and Services												
63	Classrooms	2	211 204	Operable Parts	Whiteboard

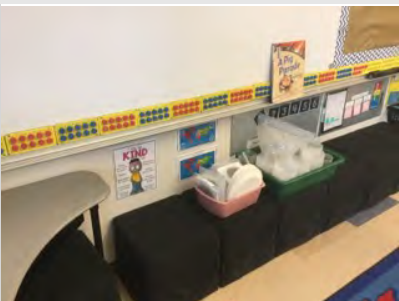
Clear floor space is not provided	-	Ensure white boards are located on an accessible route and have a 30" min. by 48" min. clear floor space.	2	Labor	\$0

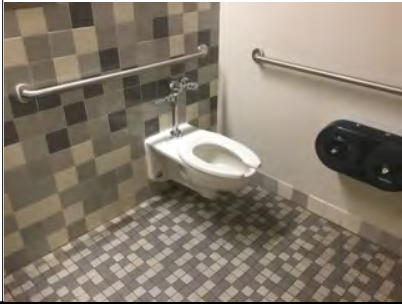
Toilet paper dispenser is not compliant	-	Replace toilet paper dispensers as they do not allow continuous paper flow.	2	353	\$706
Access to Goods and Services												
65	Classroom	3	301	Signage	Designation

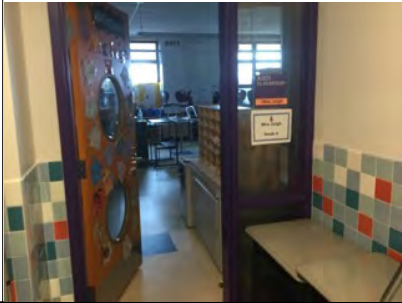
Clear floor space not provided	-	Ensure that 18" min. wide by 18" deep clear floor space is provided in front of the tactile sign.	1	Labor	\$0
Access to Goods and Services												
66	Fifth Grade Classroom	3	301	Dining or Work Surfaces	Work Surface

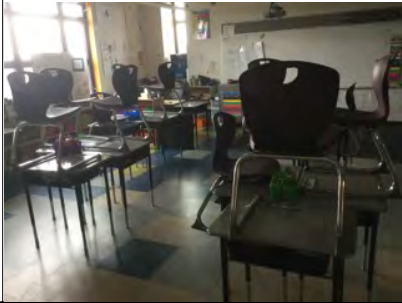
At least one or 5% accessible tables not provided	18" wide	Provide at least one (1) accessible desk with 24" min. knee clearance and 30" min. clear width.	1	350	\$350
67	Fifth Grade Classroom	3	301	Interior Access Route	N/A

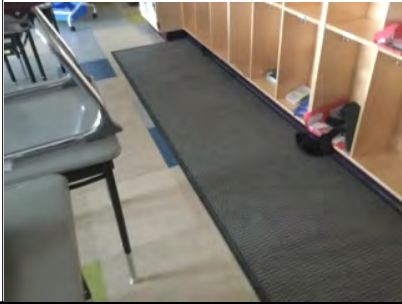
Surface not stable, firm, and slip-resistant	-	Secure the mat.	1	Labor	\$0

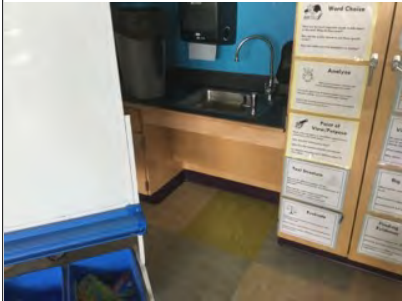
ID	Location	Floor	Room	Element	Type	Photo	Issues	Current Measure	Recommendations	Quantity	Price	Cost Estimation
Additional Access												
68	Fifth Grade Classroom	3	301	Sink	Classroom

Clear floor space not provided at sink	-	Relocate the whiteboard to provide 30" wide by 48" min. clear floor space at the sink.	1	Labor	\$0
Access to Goods and Services												
69	Fifth Grade Classroom	3	302	Dining or Work Surfaces	Work Surface

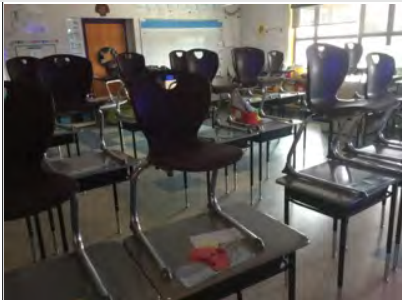
At least one or 5% accessible tables not provided	20" wide	Provide at least one (1) accessible desk with 24" min. knee clearance and 30" min. clear width.	1	350	\$350
70	Fifth Grade Classroom	3	302	Interior Access Route	N/A

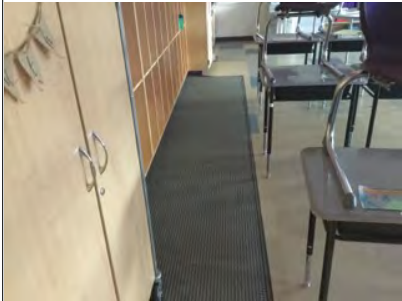
Route < 36" wide Surface not stable, firm, and slip-resistant	24" -	Reconfigure furniture to ensure that 36" min. is maintained at the accessible route. Secure the mat.	1	Labor	\$0
71	Fifth Grade Classroom	3	302	Interior Access Route	N/A

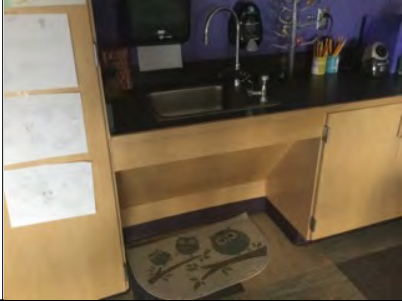
Surface not stable, firm, and slip-resistant	-	Secure the mat.	1	Labor	\$0

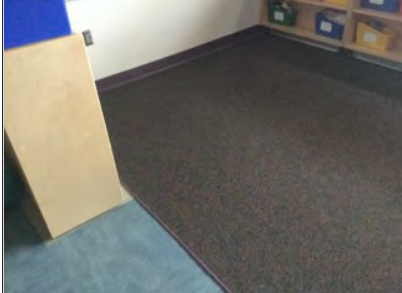
72	Fifth Grade Classroom	3	302	Interior Access Route	N/A

Surface not stable, firm, and slip-resistant	-	Secure the mat.	1	Labor	\$0

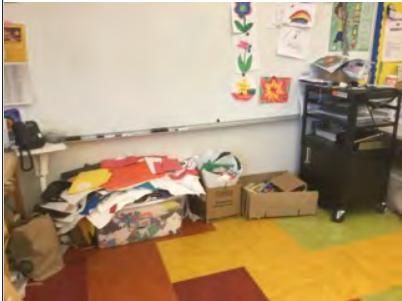
ID	Location	Floor	Room	Element	Type	Photo	Issues	Current Measure	Recommendations	Quantity	Price	Cost Estimation
Access to Goods and Services												
73	Art Room	3	303	Operable Parts	Whiteboard

Clear floor space is not provided	-	Ensure white boards are located on an accessible route and have a 30" min. by 48" min. clear floor space.	1	Labor	\$0
Access to Goods and Services												
74	OT/ PT Classroom	3	306	Interior Access Route	N/A

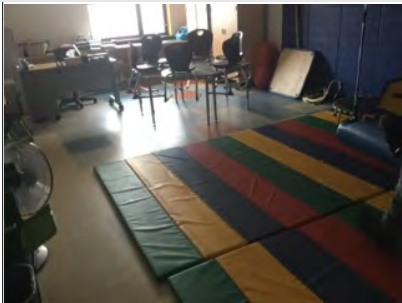
Route < 36" wide	-	Ensure that a clear width of 36" min. is maintained at the accessible route. Arrange the mats to allow for 36" clear.	1	Labor	\$0
Access to Goods and Services												
75	Fourth Grade Classroom	3	311	Interior Access Route	N/A

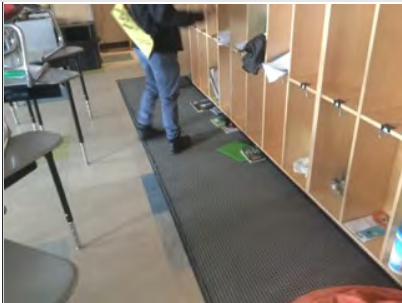
Surface not stable, firm, and slip-resistant	-	Secure the mat.	1	Labor	\$0
Access to Goods and Services												
76	Classroom	3	312	Dining or Work Surfaces	Work Surface

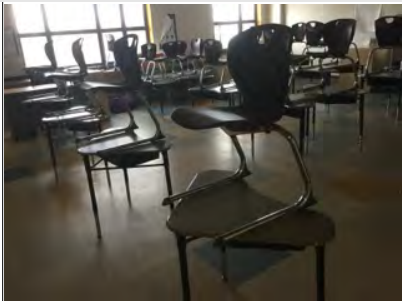
At least one or 5% accessible tables not provided	27" wide	Provide at least one (1) accessible desk with 24" min. knee clearance and 30" min. clear width.	1	350	\$350

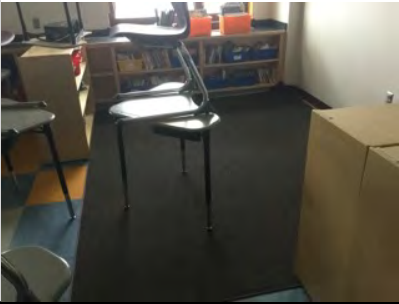
ID	Location	Floor	Room	Element	Type	Photo	Issues	Current Measure	Recommendations	Quantity	Price	Cost Estimation
Access to Goods and Services												
77	Fourth Grade Classroom	3	312	Interior Access Route	N/A

Route < 36" wide	22"	Reconfigure furniture to ensure that 36" min. is maintained at the accessible route.	1	Labor	\$0
Access to Goods and Services												
78	Small Group Room	3	314	Interior Access Route	N/A

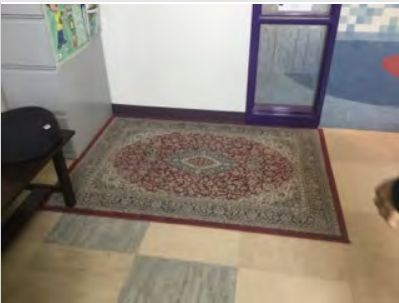
Surface not stable, firm, and slip-resistant	-	Secure the mat.	1	Labor	\$0
Toilet Rooms for Children												
79	Boys' Toilet Room	3	T31	Toilet Compartment	Accessible Compartment

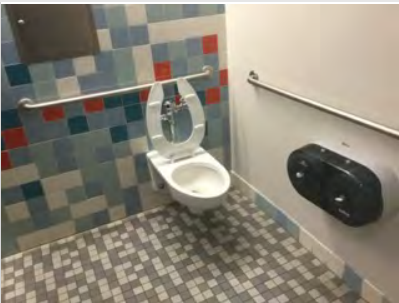
Door with malfunctioning self-closing hinge Toilet seat < 15" or > 17" high (Ages 9 - 12) Side or rear grab bar < 25" or > 27" high (Ages 9 - 12) Centerline < 15" or > 18" (Ages 9 - 12) Non-compliant toilet paper dispenser	- 18" 34" 19" -	Repair self-closing hinge. Toilet seat height and toilet centerline are not compliant but usable. Relocate grab bars to 25"- 27" above the floor. Replace the toilet paper dispenser as it does not allow continuous paper flow.	1	Labor 1059	\$1059

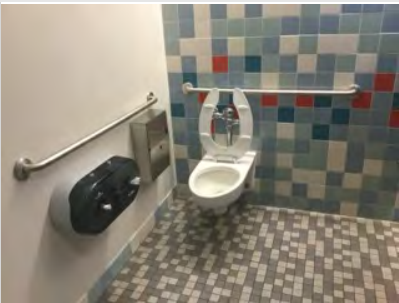
Toilet Rooms for Children												
80	Girls' Toilet Room	3	T32	Toilet Compartment	Accessible Compartment

Toilet seat < 15" or > 17" high (Ages 9 - 12) Side or rear grab bar < 25" or > 27" high (Ages 9 - 12) Centerline < 15" or > 18" (Ages 9 - 12) Non-compliant toilet paper dispenser	18" 34" 19" -	Toilet seat height and toilet centerline are not compliant but usable. Relocate grab bars to 25"- 27" above the floor. Replace the toilet paper dispenser as it does not allow continuous paper flow.	1	1059	\$1059

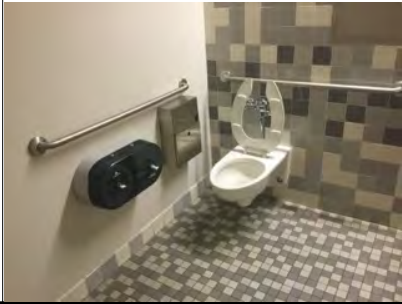
ID	Location	Floor	Room	Element	Type	Photo	Issues	Current Measure	Recommendations	Quantity	Price	Cost Estimation
Toilet & Bathing Rooms												
81	Single-User Toilet Rooms	3	T33 T34	Single-User Toilet	N/A

Toilet paper dispenser is not compliant	-	Replace toilet paper dispensers as they do not allow continuous paper flow.	2	353	\$706
Access to Goods and Services												
82	Community Garden	Ext.		Doors, Doorways, & Gates	Outdoor Gate

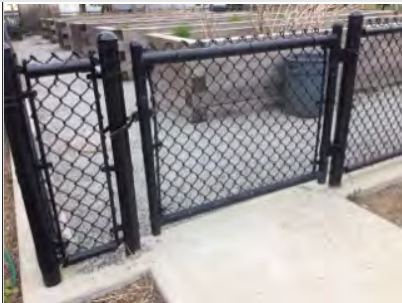
Hardware not operable with a closed fist 10" solid surface not provided	- -	Provide hardware that can be operable with one hand and not require tight grasping, pinching, or twisting of the wrist. Swinging door and gate surfaces within 10 inches of the finish floor or ground measured vertically shall have a smooth surface on the push side extending the full width of the door or gate.	1	400	\$400
Approach and Entrance												
83	Intersection of University Road and Everett Road	Ext.		Curb Ramp	Perpendicular

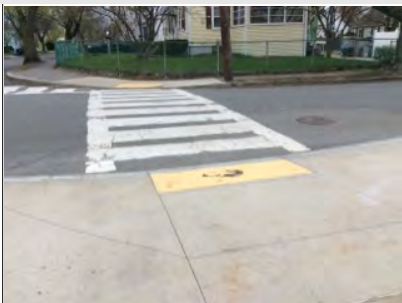
Surface not stable, firm and slip-resistant	-	Replace the deteriorated detectable warning on the curb ramp.	1	180	\$180

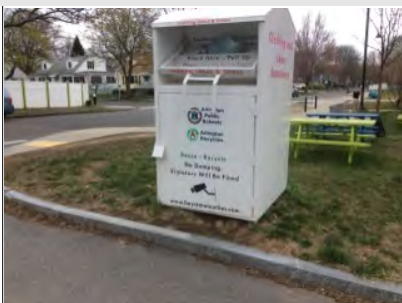
Access to Goods and Services												
84	Northwest Side of School	Ext.		Operable Parts	Trash/Recycling

Clear floor space is not provided	-	Relocate donation bin to an accessible route that has a 30" min. by 48" min. clear floor space.	1	Labor	\$0

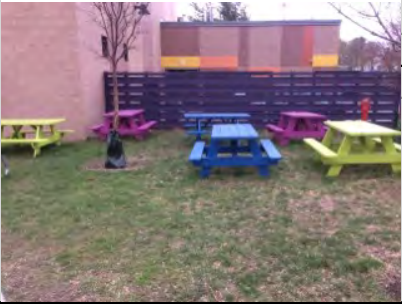
ID	Location	Floor	Room	Element	Type	Photo	Issues	Current Measure	Recommendations	Quantity	Price	Cost Estimation
Access to Goods and Services												
85	Picnic Area on Northwest Side of School	Ext.		Picnic Tables	N/A

At least 5% accessible spaces not provided Toe or knee clearance at tables not provided Picnic table not on an accessible route	- - -	Provide at least 1 dining surface (or ensure that 5% of dining surfaces) have toe and knee clearance. Ensure that the dining surface is connected to an accessible route. (Cost estimate for a dining table and 4' wide 20' long concrete route to it.)	1	2627	\$2627
Best Practice												
86	Picnic Area on Northwest Side of School	Ext.

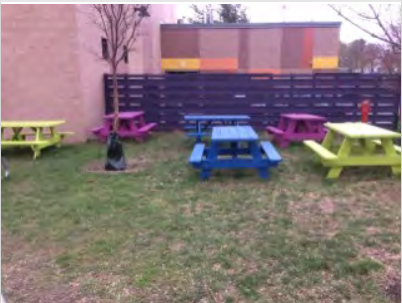
Best Practice		Best Practice: Consider providing a 48" wide route around the accessible picnic table.	1	--	\$0
Play and Sport Areas												
87	Play Area 1	Ext.		Play Areas	N/A

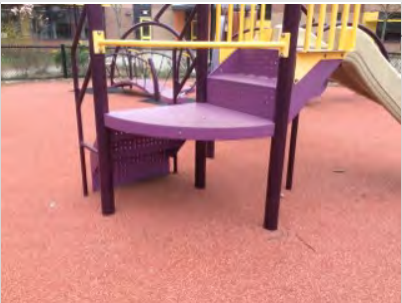
No compliant transfer system	-	Alteration might be technically infeasible.	1	--	\$0

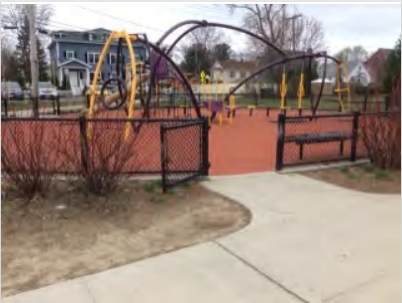
Access to Goods and Services												
88	Play Areas 1 and 2	Ext.		Doors, Doorways, & Gates	N/A

10" solid surface not provided		Swinging door and gate surfaces within 10 inches of the finish floor or ground measured vertically shall have a smooth surface on the push side extending the full width of the door or gate.	2	158	\$316

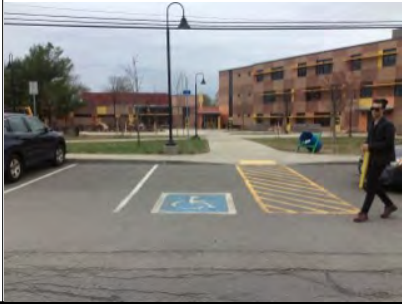
ID	Location	Floor	Room	Element	Type	Photo	Issues	Current Measure	Recommendations	Quantity	Price	Cost Estimation
Approach and Entrance												
89	Southeast Parking Lot	Ext.		Off-Street Parking Lot or Garage	Visitor

Sign not provided	-	Provide a sign with the bottom of the sign 60" min. above the ground and the top 96" max. above the ground.	1	250	\$250

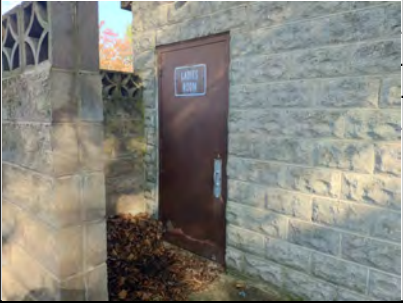
ID	Location	Floor	Room	Element	Type	Photo	Issues	Current Measure	Recommendations	Quantity	Price	Cost Estimation
Access to Goods and Services												
1	Men's and Women's Toilet Rooms	1		Signage	Designation

Raised characters not provided Braille not provided Sign not located on the latch side of the door International Symbol of Acc. not compliant	- - - -	Provide text with raised characters duplicated in braille, and the International Symbol of Accessibility. Locate sign at permanent rooms alongside the door on the latch side.	2	116	\$232
Access to Goods and Services												
2	Men's Toilet Room	1		Operable Parts	Changing Table

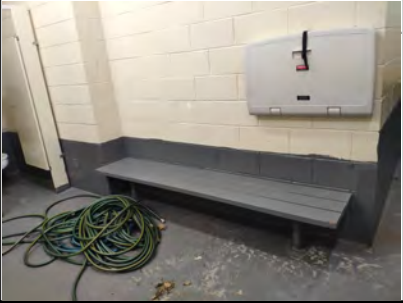
Clear floor space is not provided	-	Relocate bench to provide a 30" min. by 48" min. clear floor space at the changing table. (Cost estimate based on relocating bolted-on bench.)	1	156	\$156
Toilet & Bathing Rooms												
3	Men's Toilet Room	1		Lavatory	N/A

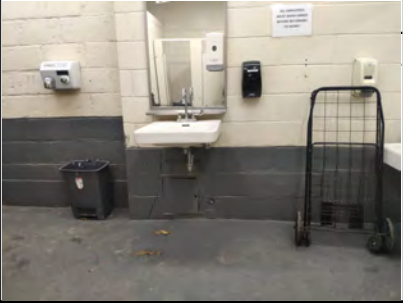
Lavatory rim or counter > 34" high Plumbing underneath is exposed	36.5" -	Provide at least one lavatory with the rim no higher than 34". Insulate or otherwise configure pipes to prevent contact at lavatory.	1	1597	\$1597

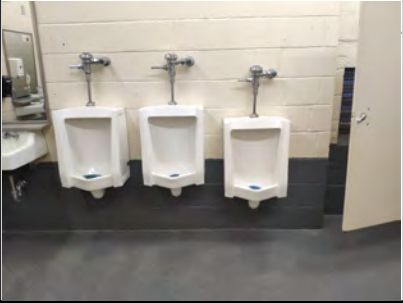
4	Men's Toilet Room	1		Urinal	N/A

Rim > 17" high	17.5"	Provide at least one urinal with the rim no higher than 17" above the finished floor. Best Practice: Provide a urinal with a rim no higher than 15" above finished floor so that it can be accessible to children.	1	1624	\$1624
5	Men's Toilet Room	1		Toilet Compartment	Accessible Compartment

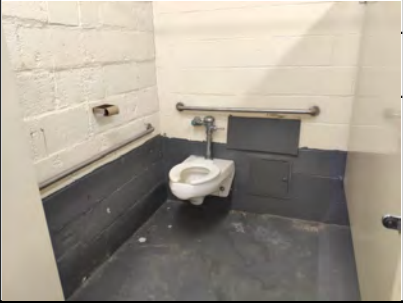
Door has malfunctioning self-closing hinge Side or rear grab bar < 33" or >36" high Non-compliant toilet paper dispenser Centerline < or > 18" (MAAB)	- 30" - 19"	Repair hinge. Relocate side grab bar between 33"- 36" above the finished floor. Relocate toilet paper so that it is located under the grab bar. Relocate toilet so the centerline is 18" from the side wall.	1	1895	\$1895

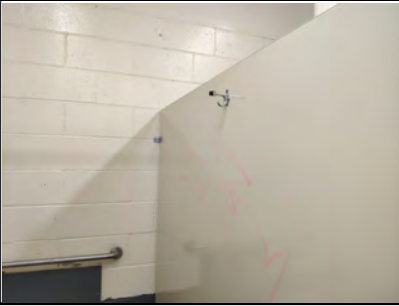
ID	Location	Floor	Room	Element	Type	Photo	Issues	Current Measure	Recommendations	Quantity	Price	Cost Estimation
6	Men's Toilet Room	1		Toilet Compartment	Accessible Compartment

Coat hook > 48"	68"	Lower coat hook so that it is no higher than 48".	1	75	\$75
Access to Goods and Services												
7	Women's Toilet Room	1		Locker Room	Women's

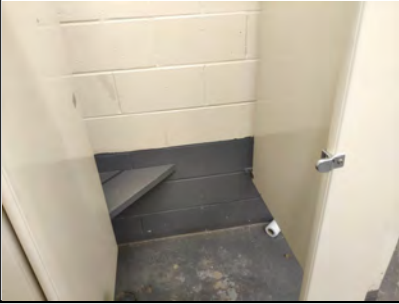
Turning space not provided	-	Provide a compliant changing room with adequate turning space. (Cost estimate based on the installation of a new changing room with 60" x 60" turning space and a compliant bench that allows transfer.)	1	2933	\$2933
Toilet & Bathing Rooms												
8	Women's Toilet Room	1		Lavatory	N/A

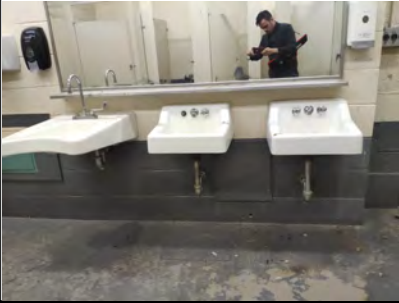
Plumbing underneath is exposed Mirror above lavatory w/reflective surface > 40"	- 43"	Insulate or otherwise configure pipes to prevent contact, for at least one lavatory. Lower mirror so that the bottom surface is at 40" max. above finished floor.	1	174	\$174

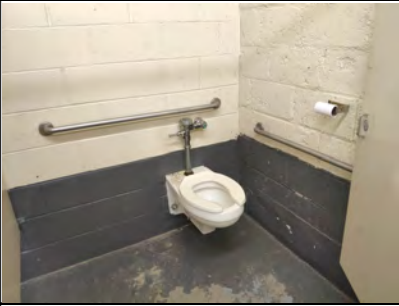
9	Women's Toilet Room	1		Toilet Compartment	Accessible Compartment

Door has malfunctioning self-closing hinge Side or rear grab bar < 33" or >36" high Non-compliant toilet paper dispenser	- 30" -	Repair hinge. Relocate side grab bar between 33"- 36" above the finished floor. Relocate toilet paper so that it is located under the grab bar.	1	481	\$481
10	Women's Toilet Room	1		Toilet Compartment	Accessible Compartment

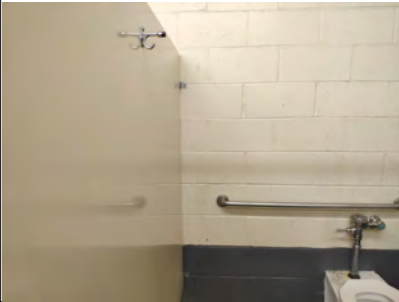
Coat hook > 48"	69"	Lower coat hook so that it is no higher than 48".	1	75	\$75

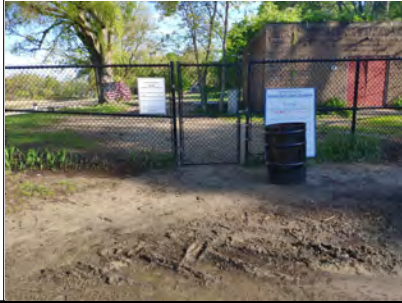
Entrance not on an accessible route	-	Stabilize or pave area in front of the entrance gate in order to provide an accessible route at this entrance, and accessible level surface at the entrance signs and trash container. (Cost estimate for 6' x 10' concrete area.)	1	260	\$260
Access to Goods and Services												
13	Entrance Gate Near Parking	Ext.		Doors, Doorways, & Gates	N/A

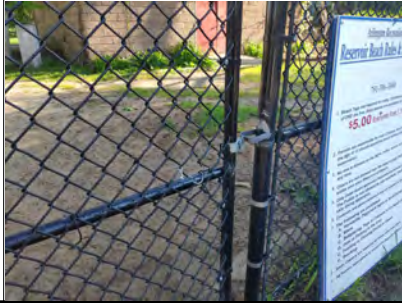
Hardware not operable with a closed fist 10" solid surface not provided	-	Provide hardware that can be operable with one hand and not require tight grasping, pinching, or twisting of the wrist. Swinging door and gate surfaces within 10 inches of the finished floor or ground measured vertically shall have a smooth surface on the push side extending the full width of the door or gate.	1	400	\$400

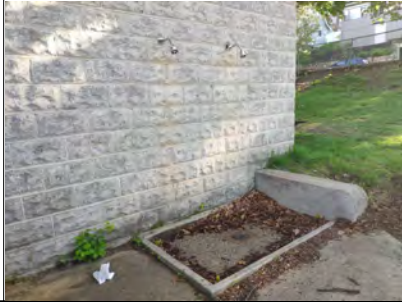
Toilet & Bathing Rooms												
14	Outdoor Showers	Ext.		Shower Compartment	Other

Roll-in type shower has a curb (MAAB)	-	Remove the curb at one exterior shower for men and one for women.	2	403	\$806

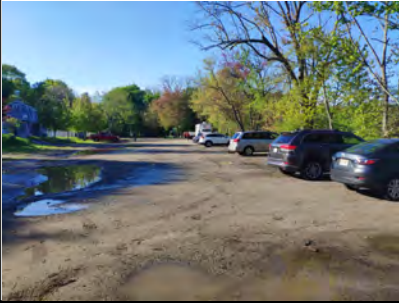
ID	Location	Floor	Room	Element	Type	Photo	Issues	Current Measure	Recommendations	Quantity	Price	Cost Estimation
Approach and Entrance												
15	Parking Area	Ext.		Off-Street Parking Lot or Garage	Visitor

Total # of parking Total # of designated accessible parking spaces	~50 0	Provide at least two (2) accessible spaces. Ensure at least one (1) space is van accessible. (Cost estimate based on the installation of two accessible spaces with compliant dimensions and signage.)	2	400	\$800
Approach and Entrance												
16	Route Between Toilet Rooms	Ext.		Exterior Access Route	Exterior

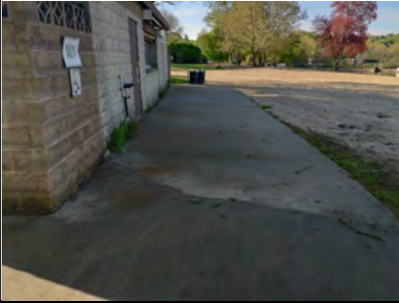
Cross slope > 1:50 (2.00%)	5%	Reduce cross slope to be no steeper than 1:50 (2.00%). (Cost estimate based on the regrading of 50 ft. of concrete.)	1	750	\$750
Approach and Entrance												
17	Route From Bath House to Beach	Ext.		Exterior Access Route	Exterior

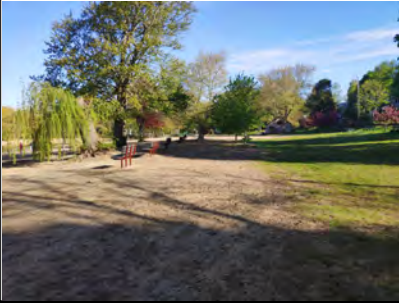
Accessible route not provided	-	Ensure a 72" wide stable and firm route is provided to the beach. Beach access routes must connect to the normal recreation water level at reservoir beaches. (Cost estimate based on the installation of a 170 linear foot beach mat.)	1	8500	\$8500

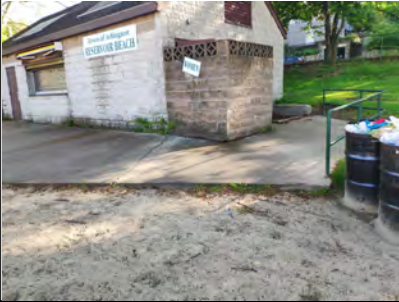
Level changes > 1/4"	2.25"	Alter change in level to be 1/4" high max.	1	103	\$103

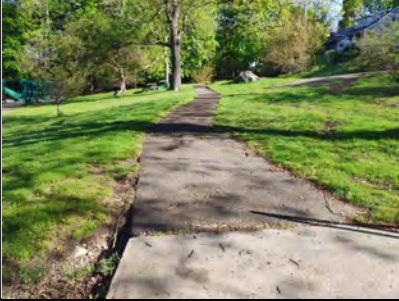
ID	Location	Floor	Room	Element	Type	Photo	Issues	Current Measure	Recommendations	Quantity	Price	Cost Estimation
Approach and Entrance												
20	Route to Northern Entrance Along Lowell Street	Ext.		Exterior Access Route	Walkway

Level changes > 1/4"	.75"	Alter change in level to be 1/4" high max.	1	103	\$103
Best Practice												
21	Route to Northern Entrance Along Lowell Street	Ext.

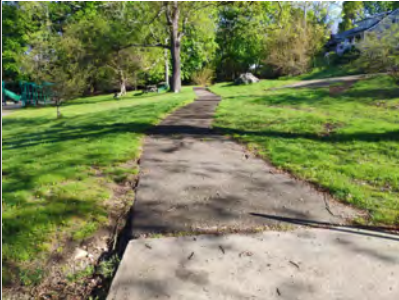
Best Practice: Consider adding railings along this pathway in order to increase access on sloped walkways.	1	0	\$0

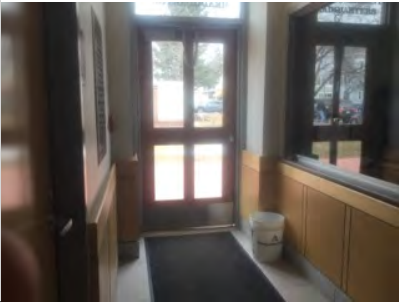
ID	Location	Floor	Room	Element	Type	Photo	Issues	Current Measure	Recommendations	Quantity	Price	Cost Estimation
Approach and Entrance												
1	Main Entrance	1		Emergency Exit	N/A

International Symbol of Acc. not provided Maneuvering clearance(s) not provided Mat not securely attached	- - -	Provide the International Symbol of Accessibility viewable from outside the door at the entrance. Provide an automatic door opener. Secure the walk-off mat.	1	1696 Labor	\$1696
Access to Goods and Services												
2	Main Entrance	1		Means of Egress	N/A

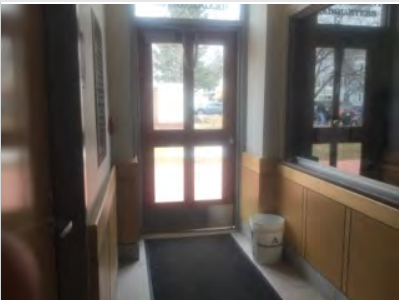
Tactile exit sign not provided	-	Ensure tactile exit signs with raised characters and braille are provided at exit doors. Mount signs between 48"- 60" above finish floor located on the latch side of the door.	1	116	\$116
Access to Goods and Services												
3	Near Elevator	1		Interior Access Route	N/A

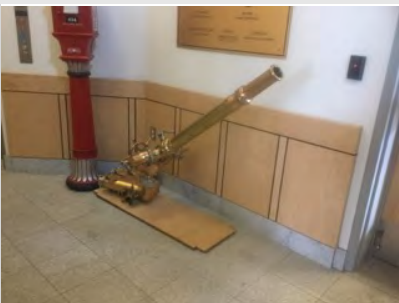
Obstructed by protruding objects	42.25"	Rotate the statue 180 degrees so the the protruding section is facing the red post and wall.	1	Labor	\$0

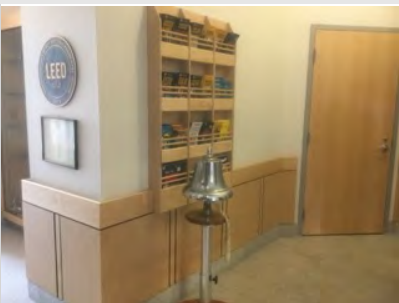
Access to Goods and Services												
4	Pamphlet Display	1		Operable Parts	Other

Reach < 15" or > 48"(forward/side approach)	72.5"	Relocate forms to be between 15"- 48" above finish floor.	1	Labor	\$0

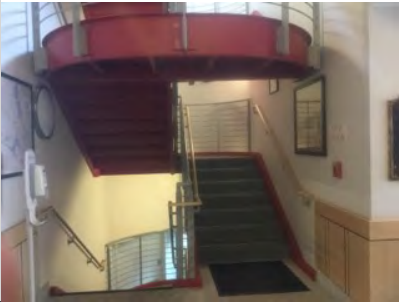
ID	Location	Floor	Room	Element	Type	Photo	Issues	Current Measure	Recommendations	Quantity	Price	Cost Estimation
Access to Goods and Services												
5	Stairway	1		Interior Access Route	N/A

Minimum vertical clearance not provided	77"	Providing the 80" high minimum head clearance may be technically infeasible. Consider adding signage that says, "Low Headroom" or, "Low Ceiling".	1	116	\$116
Toilet & Bathing Rooms												
6	Toilet Room	1		Lavatory	N/A

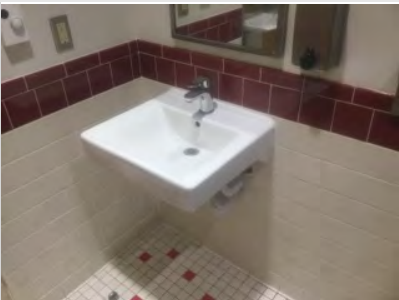
Mirror above lavatory w/reflective surface > 40"	43"	Lower mirror so that the bottom surface is at 40" max. above finish floor.	1	128	\$128
Access to Goods and Services												
7	Chief's Office	2		Doors, Doorways, & Gates	Office

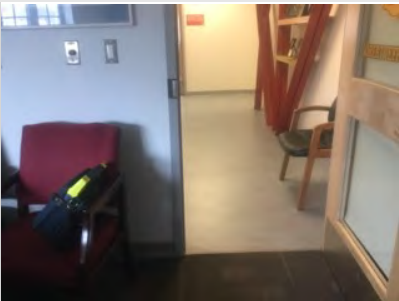
Maneuvering clearance(s) not provided	11.75"	Move the chair, as it is an obstruction to the door maneuvering clearance. Ensure it is 18" min. away from the latch side of the door.	1	Labor	\$0
Access to Goods and Services

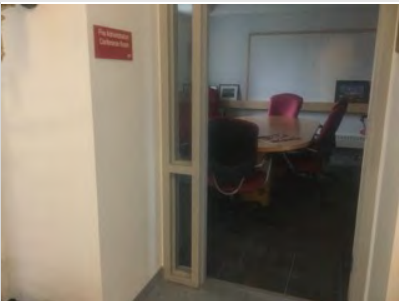
8	Conference Room	2		Doors, Doorways, & Gates	Meeting Room

Maneuvering clearance(s) not provided	10.75"	Provide an automatic door opener.	1	1530	\$1530

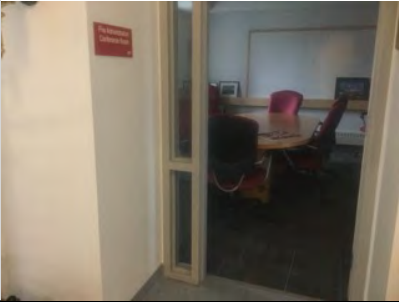
ID	Location	Floor	Room	Element	Type	Photo	Issues	Current Measure	Recommendations	Quantity	Price	Cost Estimation
9	Conference Room	2		Assembly Area	N/A

Assistive listening devices not provided	-	If audible communication is integral to the use of the space, provide an assistive listening system.	1	1214	\$1214
Best Practice												
10	Conference Room	2

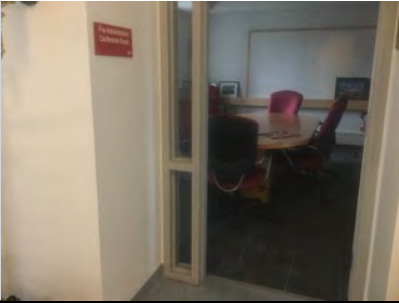
-	Best Practice: In the conference room, consider providing an adjustable height ADA accessible podium with room for knee and toe clearance. (Cost estimate: \$3,000)	1		\$0
Access to Goods and Services												
11	Outside Conference Room	2		Interior Access Route	N/A

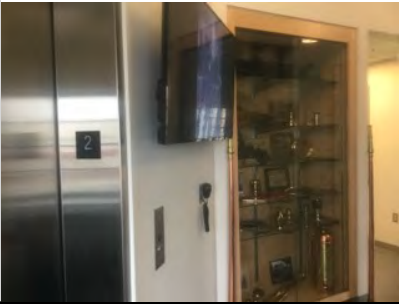
Obstructed by protruding objects	5"	Relocate the TV or position it so that it protrudes no more than 4" into the circulation path.	1	Labor	\$0
Best Practice												
12	Outside Conference Room	2

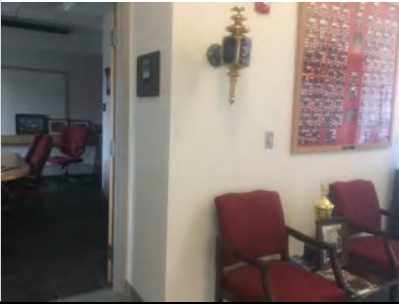
The wall sconce would act as a protruding object if the chair were not there. Ensure a cane detectable object is always underneath the sconce.	1		\$0

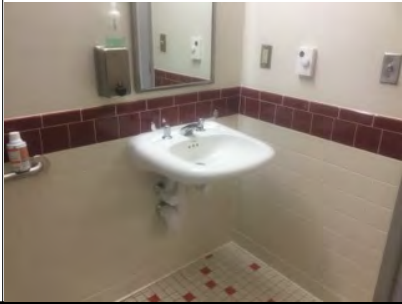
ID	Location	Floor	Room	Element	Type	Photo	Issues	Current Measure	Recommendations	Quantity	Price	Cost Estimation
Toilet & Bathing Rooms												
13	Second Floor Toilet Room	2		Lavatory	N/A

Mirror above lavatory w/reflective surface > 40"	42.7"	Lower mirror so that the bottom surface is at 40" max. above finish floor.	1	128	\$128

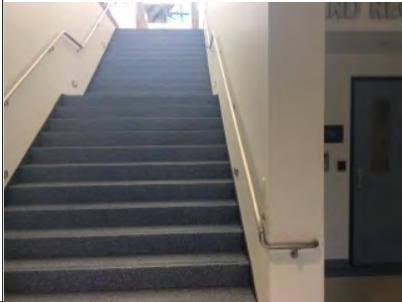
ID	Location	Floor	Room	Element	Type	Photo	Issues	Current Measure	Recommendations	Quantity	Price	Cost Estimation
Access to Goods and Services												
1	Stairs To Level 2	1	-	Stairways	Interior

Handrails do not extend 12" from stairs	-	Bottom: Ensure handrails extend to one tread depth beyond the last riser.	2	71	\$142
Access to Goods and Services												
2	Administration Counter	2	-	Service Counter	N/A

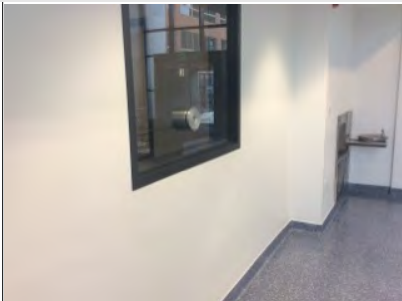
Counter > 36" high	44"	Provide a counter that is 36" max. above the ground or finish floor.	1	440	\$440
Access to Goods and Services												
3	Community Room	2	-	Doors, Doorways, & Gates	Assembly Space
